15/7/11

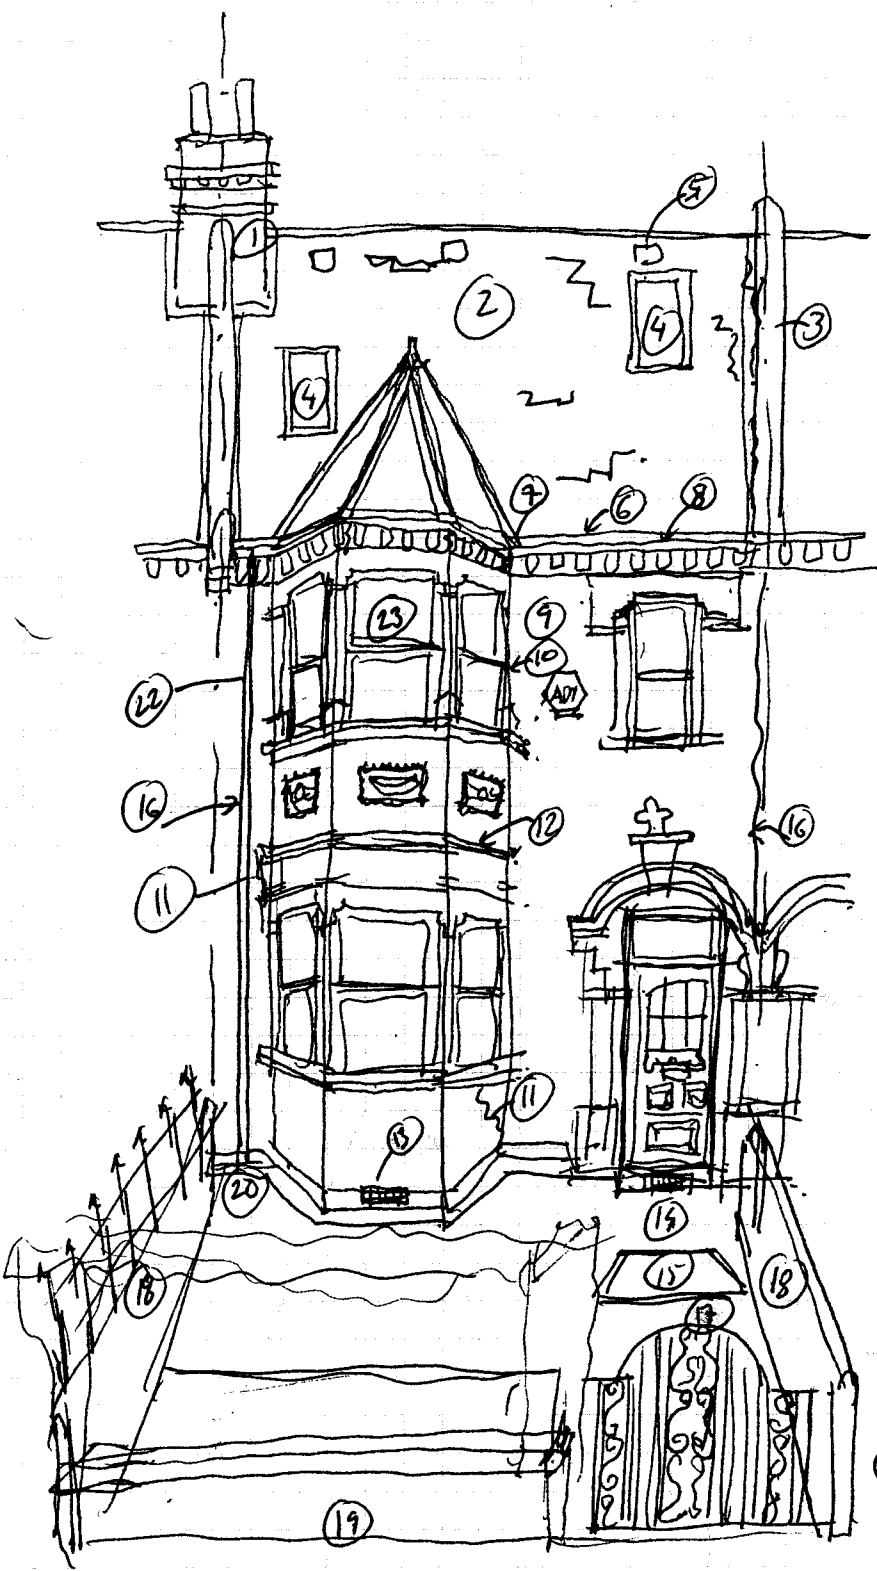
- ① CHIMNEY SOME MORTAR & TRAUCHING POINTING ELEVATION
- ② ROOF ORIGINAL SLATES - SOME CRACKED SOME SLIPPAGE.
- ③ RENDER HAS CRACKED VERTICALLY & HORIZONTALLY
- ④ Velux roof lights
- ⑤ ROOF VENTU
- ⑥ CAST IRON GUTTER SOME LEAK @ JOINTS
- ⑦ CRACKS @ INTERFACES NEEDS M/G + PAINTING
- ⑧ TIMBER GUTTER BOARD
- ⑨ FACING BRICKWORK - SOME PAINTING NEED. + ELEVATION OF BRICK
- ⑩ BAY INTERFACE MADE
- ⑪ CRACKS IN BRICKWORK.
- ⑫ STONE SILL - DRIP IS RENDERED - NEW HERE & REFORMED.
- ⑬ AIR BRICKS @ GOOD HEIGHT.
- ⑭ NEWLY PAVED ENTRANCE AREA.
- ⑮ MANTON'S
- ⑯ SOME LOOSE CABLING
- ⑰ GATE - TOP RUSTY.
- ⑱ PAINTED IN GOOD CONDITION
- ⑲ FRONT WALL + PRIVET FENCE GOOD CONDITION - SOME M/G @ BOTTOM.
- ⑳ GULLY NEEDS PROTECTION FROM LEAFS
- ㉑ DECORATION VERY RECENT.
- ㉒ PLASTIC RAIN WATER LIKE OIL.
- ㉓ SINGLE GLAZED REPLACEMENT SASH WINDOWS
