REAR ELEVATION

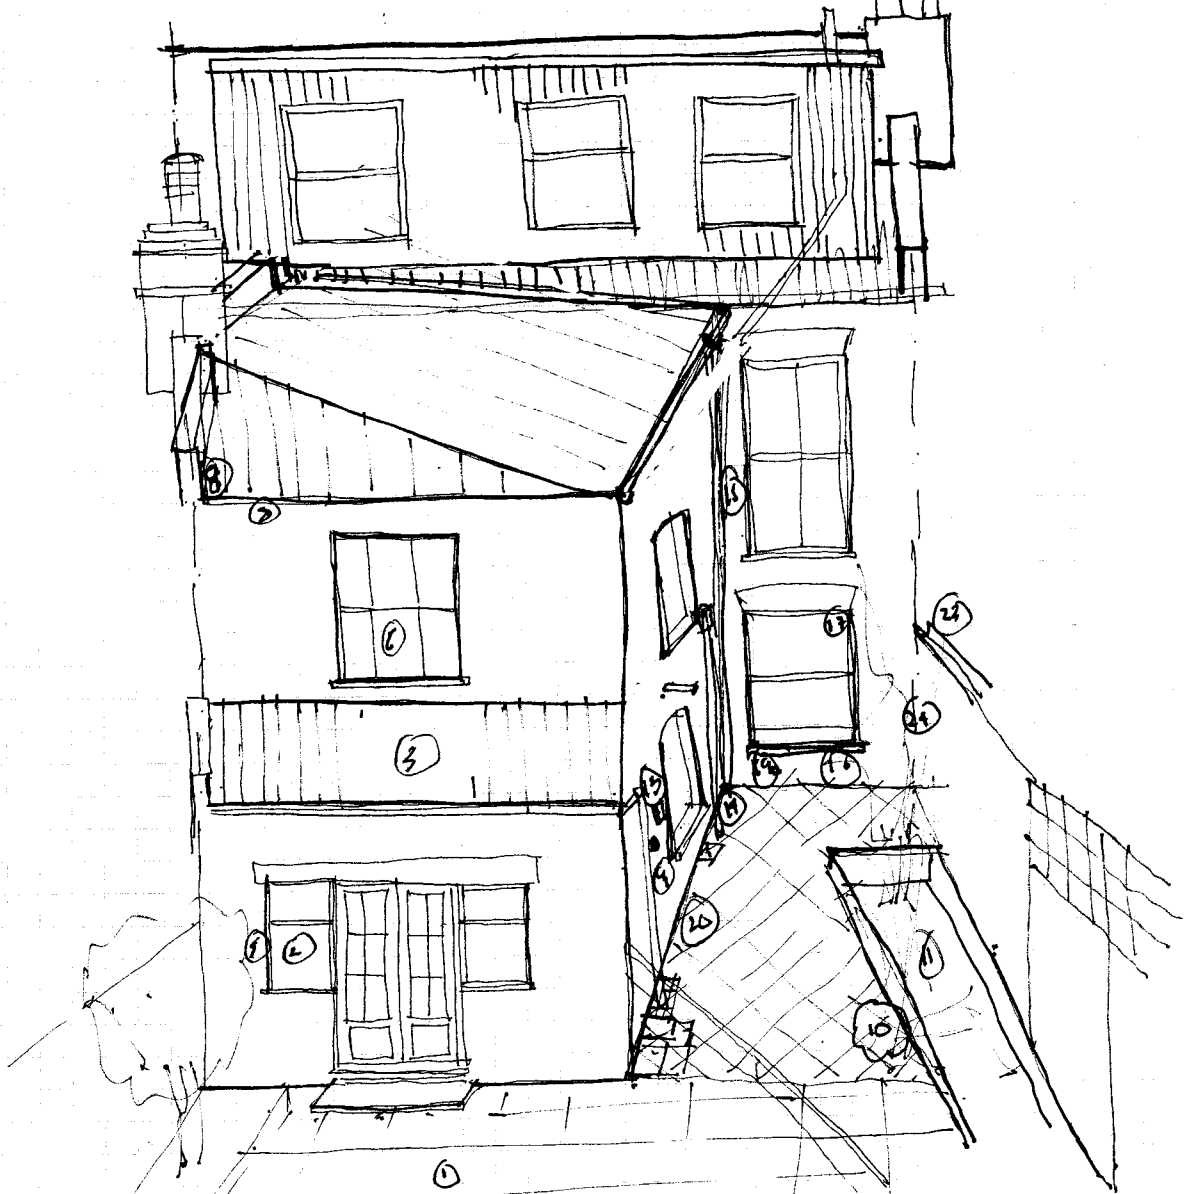
- ① PAVING SLAB - UNEVEN LEVEL.
- ② TIMBER PATIO DOOR - S/ GLAZED
- ③ PLAIN SLATE ROOF - FAIR CONDITION
- ④ UPVC PLASTIC RAIN WATER GUTTER + DOWN PIPE
- ⑤ GAP BETWEEN WINDOW FRAME + WALL
- ⑥ SINGLE GLAZED SASH WINDOW
- ⑦ EROSION OF RENDER ON PARAPET WALL
- ⑧ FASCIA BOARD NEEDS ATTENTION - BULLER FLUE
- ⑨ CRACKED QUARRY TILES
- ⑩ PLANTER BOX
- ⑪ GAP AROUND COVER STRIP OF VIBRAN. PLUG OUTLET
- ⑫ OVER FLOW PIPE ??
- ⑬ WHITE STAIN MANG AS DRAINAGE OUTLET
- ⑭ 90CST 100W DOWNWATER PIPE
- ⑮ CRACKED QUARRY TILE LILL
- ⑯ HOLE BETWEEN WINDOW FRAME + BRICKWORK
- ⑰ HOLE ???
- ⑱ WOODEN OPENING PROpped UP + WINDOW FORMER
- ⑳ IMPROVEMENT: GAP BETWEEN QUARRY TILE + WALL
- ㉑ SIGN FASCIA OF ROOF - NEEDS ATTENTION
- ㉒ THICKS @ BEAM
- ㉓ POOR GUTTER DETAIL
- ㉔ GAP IN NEIGHBOUR EXTENT AIR BRICK.
- ㉕ LAST 100W PIPE PLUGGING.
